**29. Mitteldeutsches Bau-Reko-Kolloquium  
Wittenberg (Sachsen-Anhalt), 21. April 2010**

**Historical structures for modern times, secured by respectful engineering support**  
*(Historische Tragwerke in der neuen Zeit, gesichert durch respektvolle ingenieurmäßige Begleitung)*

Dionys Van Gemert, Sven Ignoul, Gert Heirman, Kris Brosens  
K.U.Leuven & Triconsult nv, Belgium

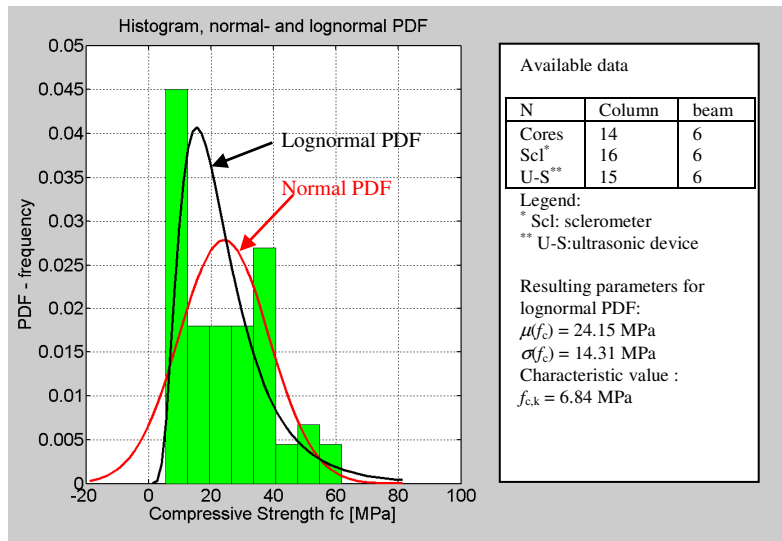
**Figure 2** Experimentally determined compressive strength – Vuurmolen Overijse  
*Gemessene Drückfestigkeiten – Dampfmühle Overijse*

Using a normal or lognormal distribution for the material property might have significant consequences on the failure probability. As an example, both probability distribution functions are used on the  $R$ - $S$  problem ( $R$  = strength;  $S$  = load level) of a concrete column in the building. This leads to the following results for the reliability index  $\beta$ :

- $\beta = 1.67$  or  $P_f = 0.047$  in case of a normal probability distribution function,
- $\beta = 5.79$  or  $P_f = 3.52 \cdot 10^{-9}$  in case of a lognormal probability distribution function.

This corresponds to a characteristic compressive strength value of  $-3.9 \text{ MPa}$  for a normal (Gauss) distribution, opposite to  $+6.8 \text{ MPa}$  for a lognormal distribution. The first value initially led to the pulling down option, whereas the second approach was the basis for the life-saving and renovation of the building.

Remark that in the first case, the structure is far from the preset target reliability, preset in Eurocode EC 0 (EN 1990-1-1:2002),  $\beta_T = 3.8$ . In the second case, the structure is judged to have a sufficient reliability. Based on these positive results, the structure has been restored and saved, Figure 3 [3].

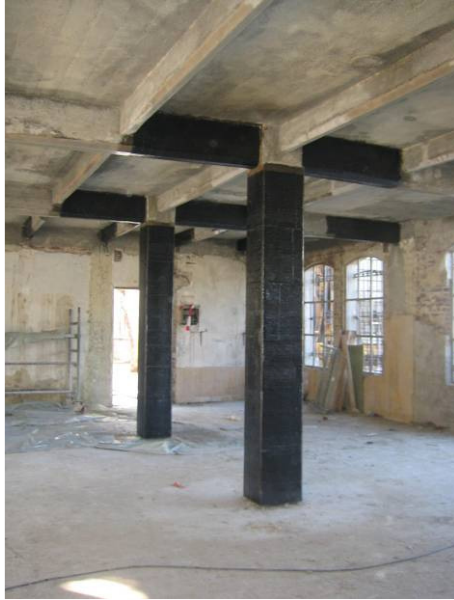
**Figure 3** Ground level, CFRP wrapping of columns and shear strengthening of beams  
*Erdgeschoss, CFRP Umwicklung von Stützen und Querverstärkung von Balken*

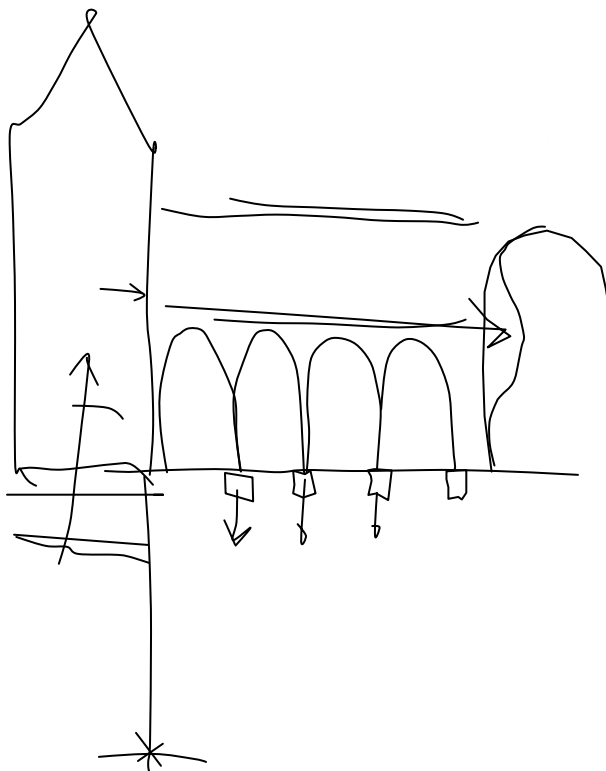
These measures were dictated by the feeling that the tower was leaning against the nave, and was pushing the nave-walls towards the transept, Figure 5.

was made with irregular intervals, and finally a profound study of the church deformations was executed by Triconsult nv in 2007 [5]. This study revealed that the crack patterns and deformations did not at all correspond to the assumed deformation scheme given in Figure 5.

**Figure 5** Leaning tower and presumed deformation scheme (architects drawing discovered at rood loft in church)  
*Überhängender Turm und vorausgesetzte Verformungen (Zeichnung des Architect, entdeckt im Doxale)*

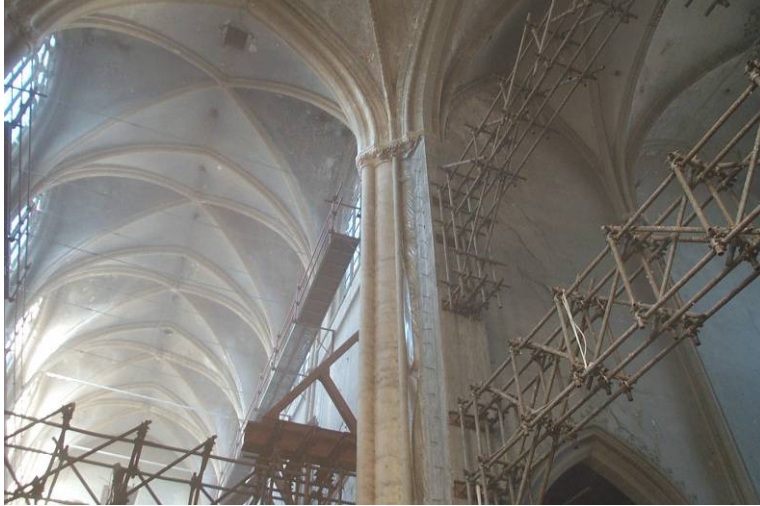
Of course, the nave and transept columns were not stiff enough to resist such pushing forces, and therefore the transept opening was stiffened with heavy concrete columns supported by steel trusses, Figure 6.

**Figure 6** Stiffening concrete column and steel trusses against crossing columns in transept  
*Versteifende Betonstützen und Stahlgerüste gegen den Vierungstützen im Querschiff*

The tower is not leaning and pushing against the nave. Therefore, the concrete stiffening columns and the stiffening trusses are not needed. The preliminary works, executed in the period 1963-1971, are now a major part of the restoration problem or project. The therapy will essentially consist of the following different phases and measures: strengthening of foundations of columns and tower; consolidation of nave columns; crack repairs; removal of concrete and steel stiffening elements.

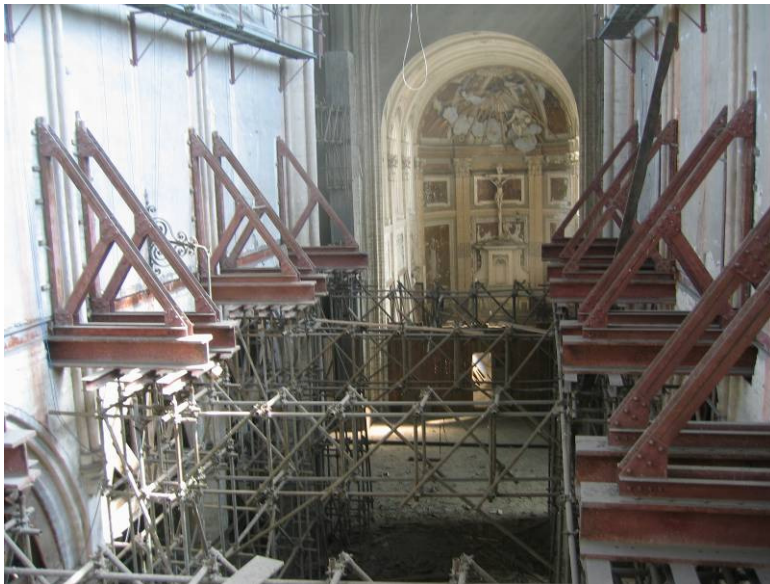
Moreover, the nave columns were unloaded by supporting the nave walls with heavy steel beams positioned on steel trusses, Figure 7.

**Figure 7** Supporting structure for the nave walls  
*Tragende Hilfskonstruktion für die Schiffmauer*

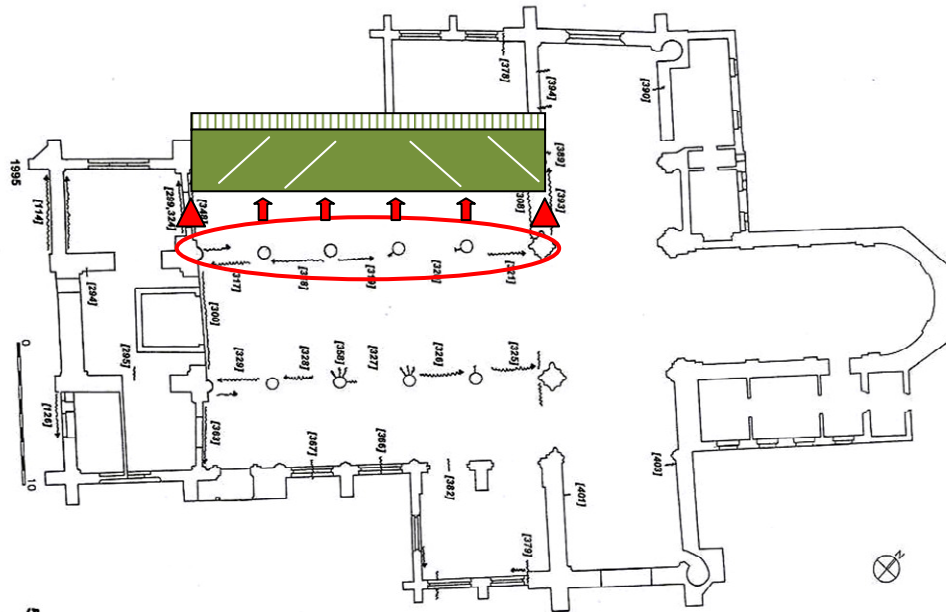
The nave columns undergo larger settlements than the tower and the transept, and the nave walls are loaded as beams, deflecting in between the tower and the transept, Figure 8.

**Figure 8** Plan of church, with scheme of cracks in nave walls  
*Grundriß der Kirche, mit Rißbild in der Schiffmauer*

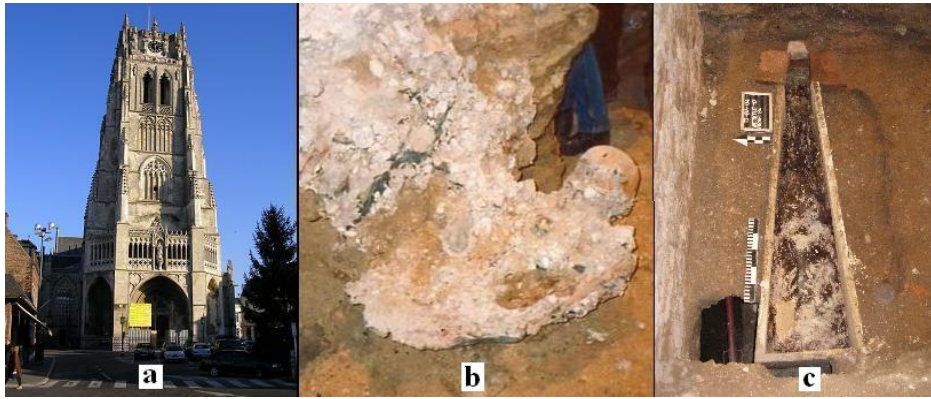
Although the main objective concerning the consolidation and strengthening of the foundation masonry was successfully executed with the cement based grout in phase I of the project, there were some disadvantages using this type of grout. Cement based grouts tend to remain very fluid for several hours, causing damage. Some valuable inscriptions on lime stone fragments were lost and even a skeleton was accidentally injected, Figure 11(b).

**Figure 11** (a) West view of the tower of the Basilica at Tongeren; (b) Unwanted “consolidation” of a skeleton; (c) Sarcophagus next to the chain wall (excavated in phase II)

In phase II, it was attempted to prevent this unwanted filling of sarcophaguses, skeletons and inscriptions by using a different grouting material. The aim was to develop a mixture that not only satisfied all the requirements needed for structural strength but also limited the fluidity in time. In that way, the unwanted consolidation of valuable artefacts is reduced to a minimum.

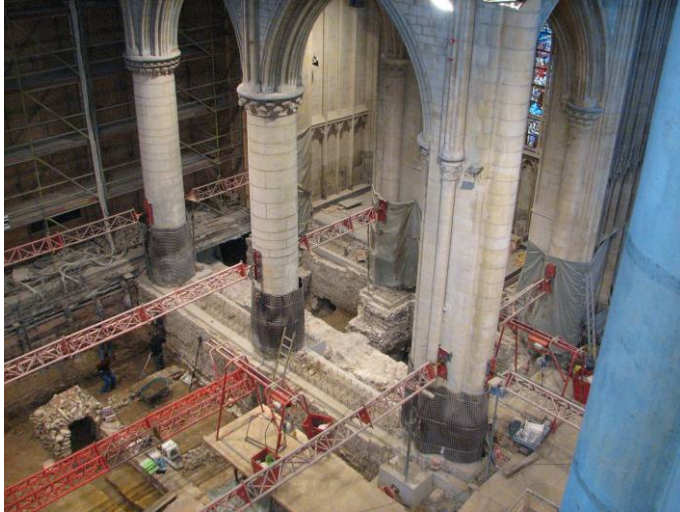
**Figure 13** General view of the excavations. Steel struts prevent buckling of wall-column system

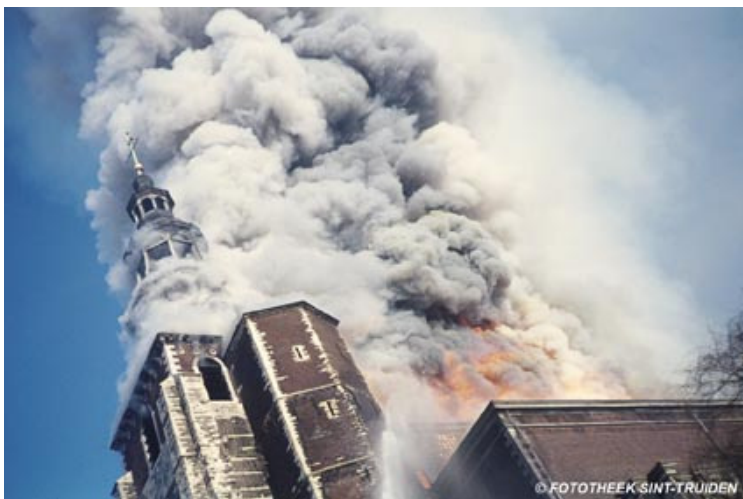
**Figure 16** Fire of 09.12.1975, attacking tower, church and school buildings in former abbey (Fototheek Sint-Truiden)  
*Brand von 09.12.1975 zerstörte Turm, Kirche und Schule der Abtei (Fototheek Sint-Truiden)*

On 9<sup>th</sup> December 1975 the abbey church completely burned down, Figure 16, and the tower was transformed into a ruin. After long and tedious discussions of the Flemish Heritage and Monuments Department with owners and the population of the city of Sint-Truiden, it was finally decided to open up the ruin of the tower by making it accessible to people, as part of the rehabilitation project “Kerkveld” (Church Field) comprising not only the tower, but also the remains of the former church, its crypt, a small theatre, all connected to the Great Market

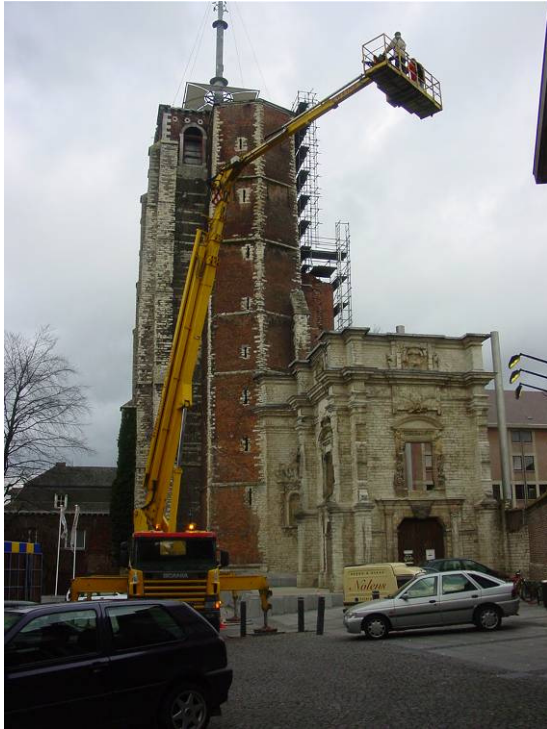
**Figure 17** Ruin of tower after fire of 1975, with millennium spire (2000)  
*Turmruipe nach dem Brand, mit Millennium Spitze (2000)*

Indeed, the metal spire was installed for the millennium turn 2000, with webcams that could be consulted via internet. However, this construction could not please the inhabitants of Sint-Truiden. So discussion on the restoration started again, leading to the project of integration and opening up of the tower, as it was executed in 2003-2004 [10].

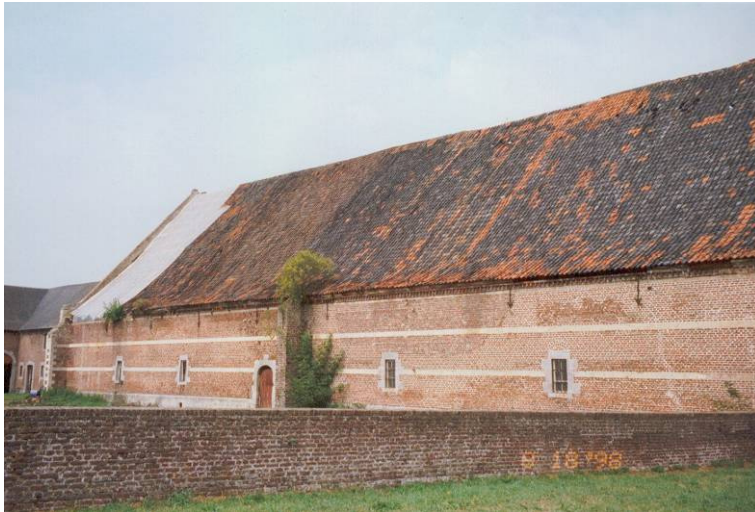
**Figure 21** Abbey Barn before restoration  
*Zehntscheune vor Restaurierung*

Due to a lack of maintenance, the wooden roof structure was heavily deteriorated. Large roof parts had disappeared, causing wood deterioration due to water infiltration. The entire wooden structure was in bad condition. The high moisture content of the wooden structure was an ideal climate for fungal growth.

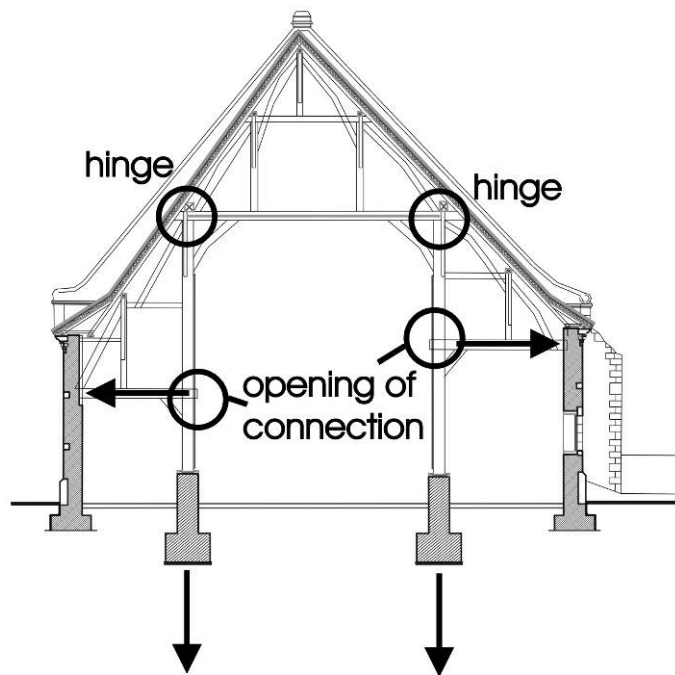
However, an insufficient foundation of the oak wooden columns and the large weight of the products stored in the barn caused an important settlement of these columns. The vertical movement of the columns imposed a horizontal pressure on the masonry walls. A scheme of these deformations is shown in Figure 23. Witnesses of these movements are the opened connections between the columns and the horizontal beams connected to the walls.

**Figure 23** Differential settlements caused horizontal loads on the walls  
*Differentielle Senkungen verursachten horizontale Kräfte auf die Mauer*

To prevent further settlements of the oak wooden columns, a new concrete foundation was designed, Figure 24. This foundation has a larger contact surface and is constructed at a larger depth where good soil conditions were at hand. The connection between the wooden column and the concrete pedestal has to work as a hinge. This is obtained by drilling in 4 steel anchors, which cross each other in the interface between the pedestal and the column.

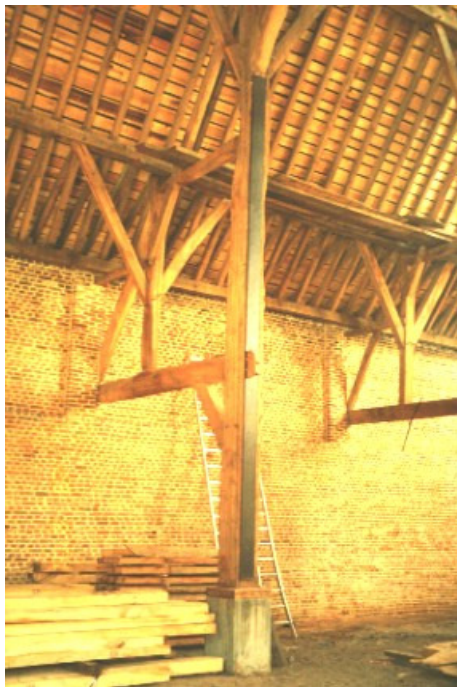
**Figure 24** Bonded steel plate on wooden column, supported by new concrete pedestal  
*Geklebte Stahlplatte auf Holzstütze, ruhend auf neuem Betonpedestal*

The stiffened column is shown in Figure 24.

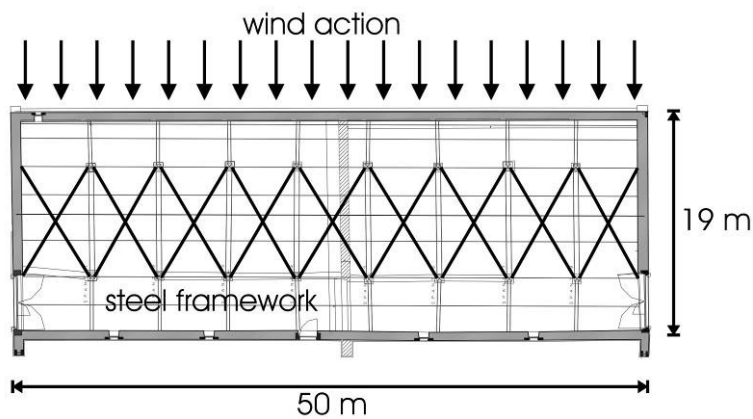
**Figure 25** Steel framework to improve wind stability  
*Stahlfachwerk für Windstabilität*

Additional to the steel plate bonding a horizontal steel truss is constructed between the 8 rafters and the front and back wall at a height of 10 m. This framework consists out of steel tie bars  $\varnothing 42$  (Tensor-Detan system). These bars are connected to the rafters. A schematic view of the horizontal framework is shown in Figure 25. The framework after completion of the restoration is shown in Figure 26.

All these measures will reduce the possible deformations to a calculated maximum of 2 cm. This deformation will cause no damage to the wooden structure, or to the masonry walls. The ductile behaviour of the masonry brickwork and the lime mortar is able to take that amount of deformation without cracking of the masonry walls.

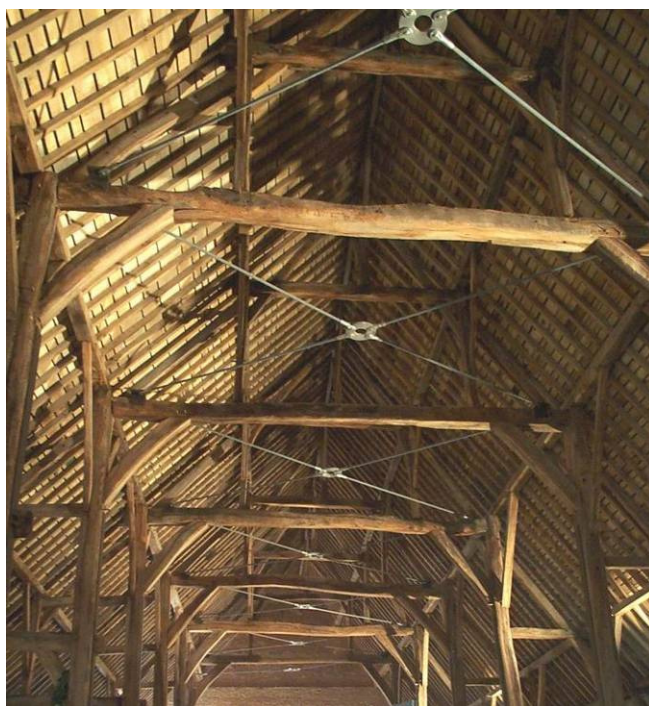
**Figure 26** Framework after completion of restoration  
*Montiertes Stahlfachwerk*
